May 4, 2021

**Re: Privacy Wall Geotechnical Investigation
Huntington HOA
Safety Harbor Florida
FGE Project Number 201452**

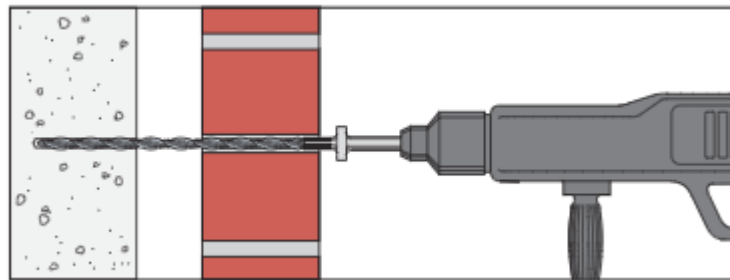
The second are primarily where the brick fascia is detaching from the wall (likely to water intrusion). This can be repaired by installing a retrofit brick repair tie. A good quality and readily available type is the Simpson Heli-Tie™ Helical Wall Tie. The ties are simply drilled into the mortar bed of the existing brick and epoxied in-place to reconnect the brick to the wall structure.

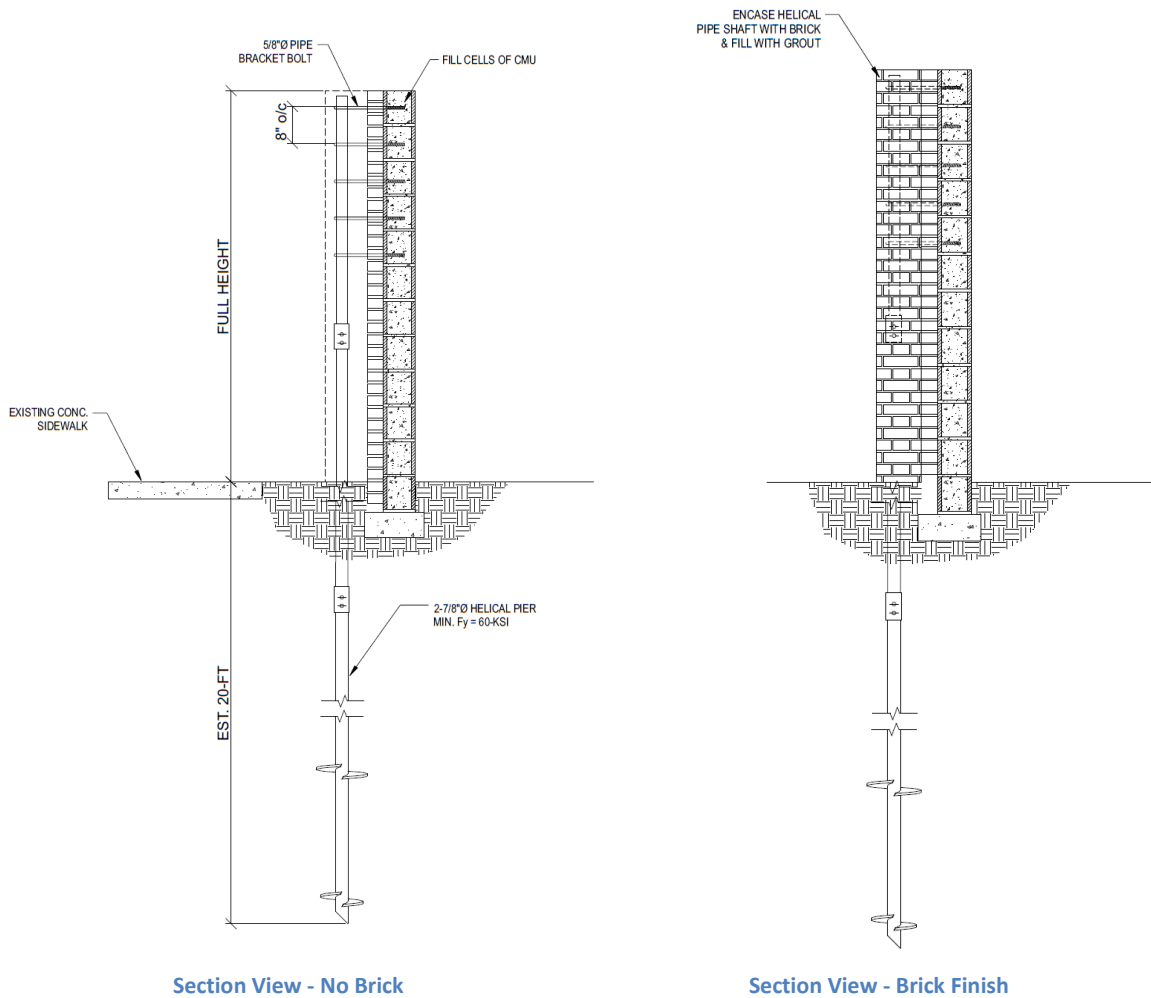
The third type of damage is a little more severe where the walls are leaning out of plumb. Two options to repair this are available. The first requires at least 10-ft of land directly next to the wall, and is referred to as a butress. The second, can be installed in limited access areas. It is a customized repair method designed by FGE for your situation. See below.

The Helical pile would be installed to a design depth, then mechanically fastened to the wall as shown above. Then can be encased in a brick finish for ascetics. This will provide the wall adequate lateral stability to be safely operated while funds for a new wall are procured.
