May 4, 2021

**Re: Privacy Wall Geotechnical Investigation
Huntington HOA
Safety Harbor Florida
FGE Project Number 201452**

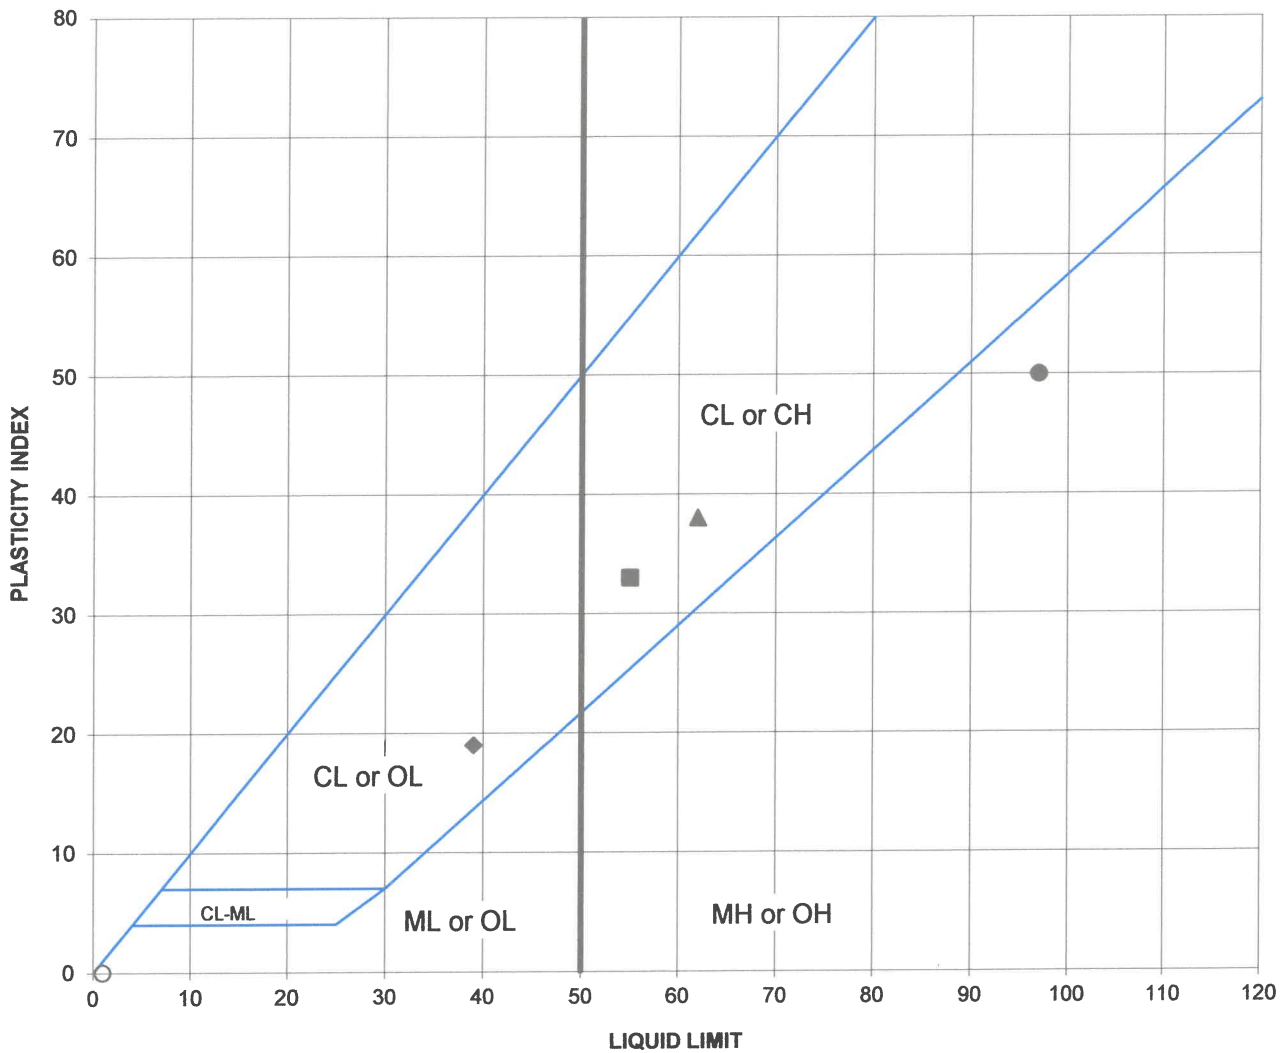
LIQUID AND PLASTIC LIMITS

The laboratory analysis of the clayey soil samples shows that the shallow clayey soils have the ability to shrink and swell in response to moisture changes. The organic analysis of one sample from HA-9 contained an organic content of 9.2%. Soils with organic contents greater than 5% are generally considered unsuitable as foundation bearing soils.

Symbol	Source	Depth	USCS	In-situ Moisture Content, %	Plastic Limit	Liquid Limit	Plasticity Index	Liquidity Index
●	HA-2	5-6'	CL		47	97	50	
■	HA-3	3-4'	CL		22	55	33	
▲	HA-4	6-7'	CH		24	62	38	
◆	HA-7	5-6'	CL		20	39	19

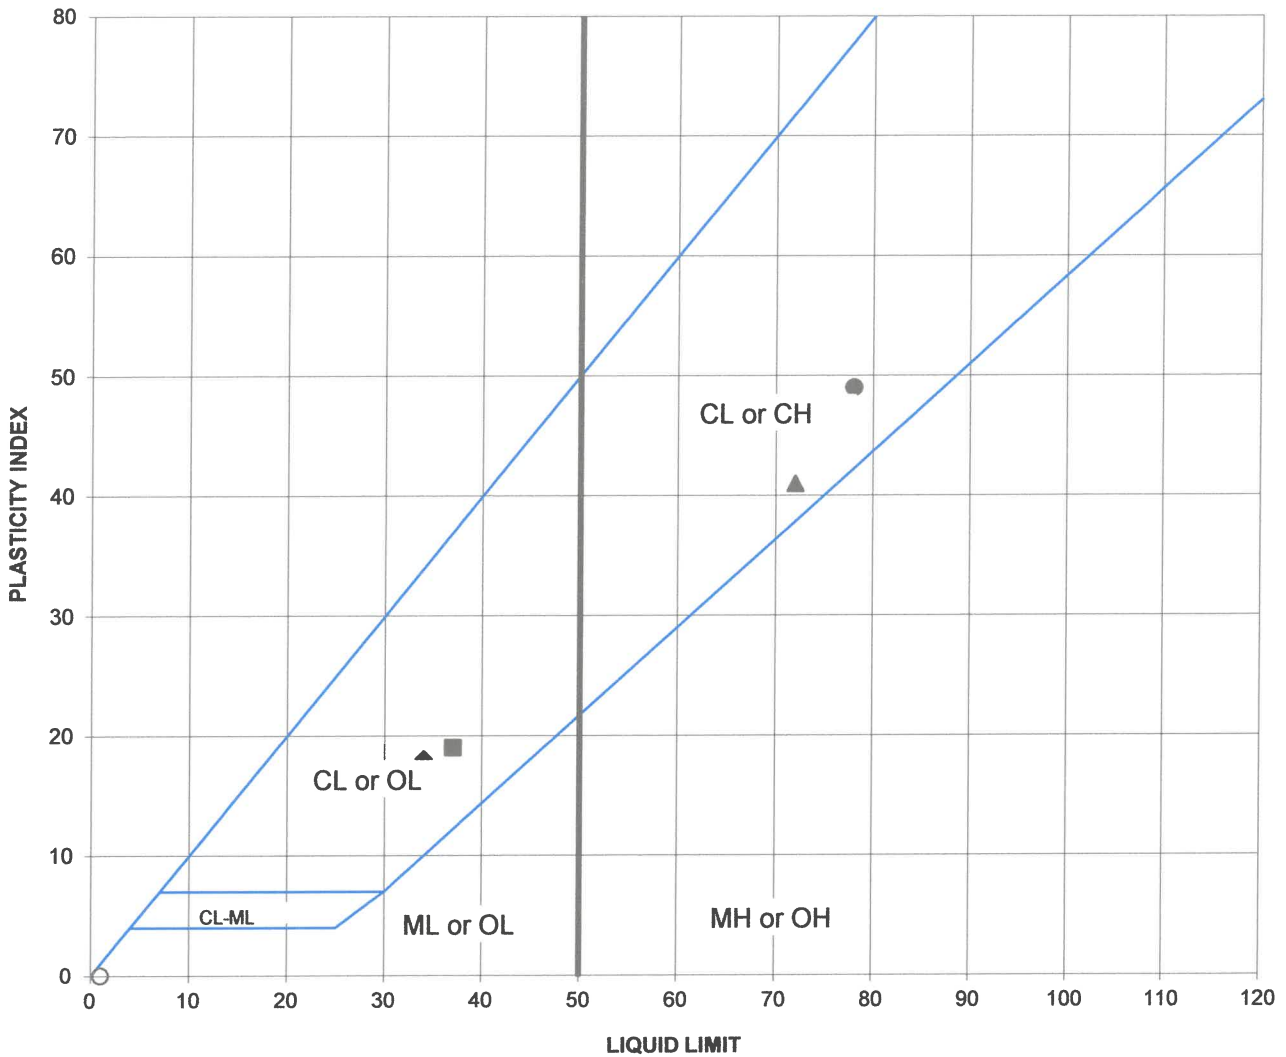
LIQUID AND PLASTIC LIMITS

Symbol	Source	Depth	USCS	In-situ Moisture Content, %	Plastic Limit	Liquid Limit	Plasticity Index	Liquidity Index
●	HA-8	4-5'	CL	#DIV/0!	29	78	49	#DIV/0!
■	HA-8	1-2'	CL	#DIV/0!	18	37	19	#DIV/0!
▲	HA-6	4-5'	SC	#DIV/0!	31	72	41	#DIV/0!
◆	HA-1	3'	CL	#DIV/0!	16	34	18	#DIV/0!
